3 Results and learnings from VSBK 1

Mid Course Review and Modifications

Second phase of operation

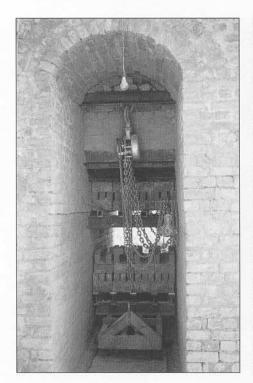
Fig. 4: Shaft 1: Chain pulley unloading arrangement

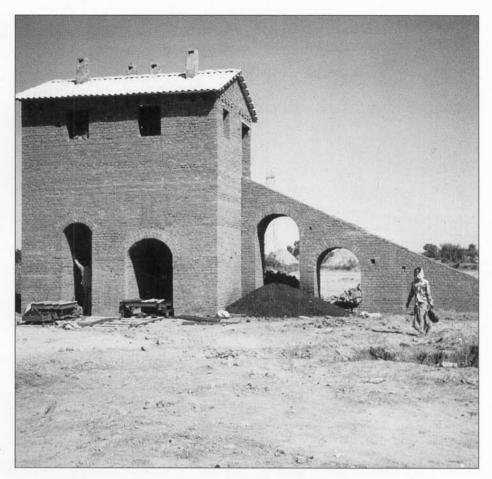
Fig. 7: Kiln after completion of construction before modification

These modification were incorporated in the kiln during October - November 1996 within the idle period of shut down due to rainy season (Fig. 7 and 8).

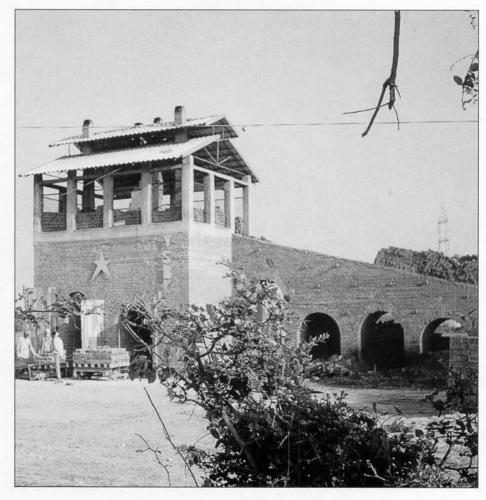
Fig. 8: Kiln after modification

- Open out the loading platform by replacing the walls with columns and grills,
- Increase height of shafts by one batch from 8 to 9,
- Increase the height of stack by about 1 metre.
- Increase the gap in roof monitor from 350mm to 700mm,
- Provide flues and dampers at two levels at the top of the shaft,
